## Asbestos Inspection Report

4-16-09

RE: Asbestos inspection at the ASARCO laboratories located at 3340 South 300 West SLC, Utah. Address also listed as 700 Gladiola St. SLC, Utah.

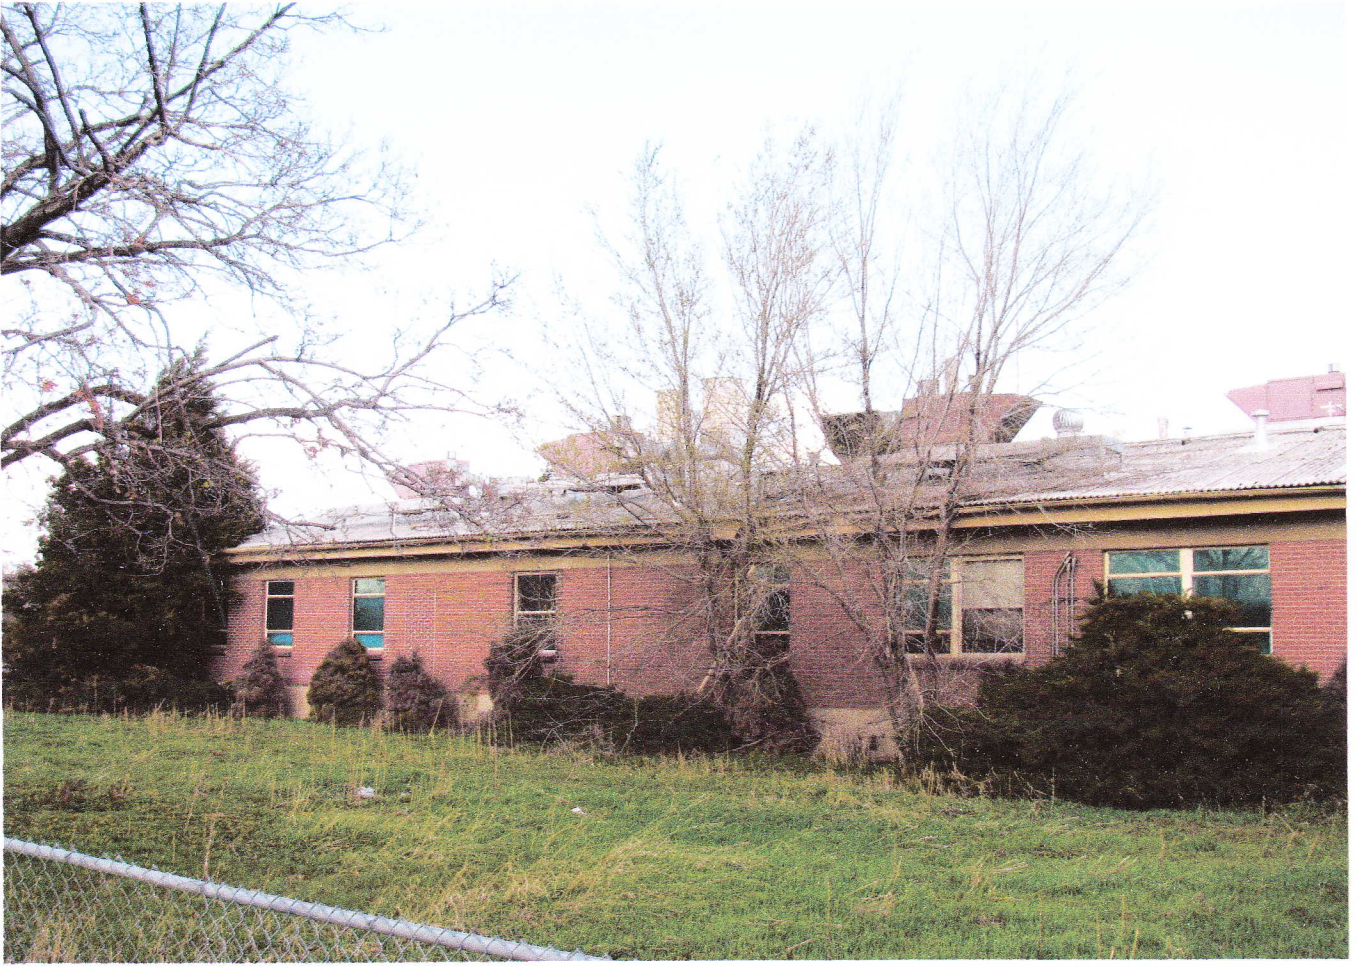
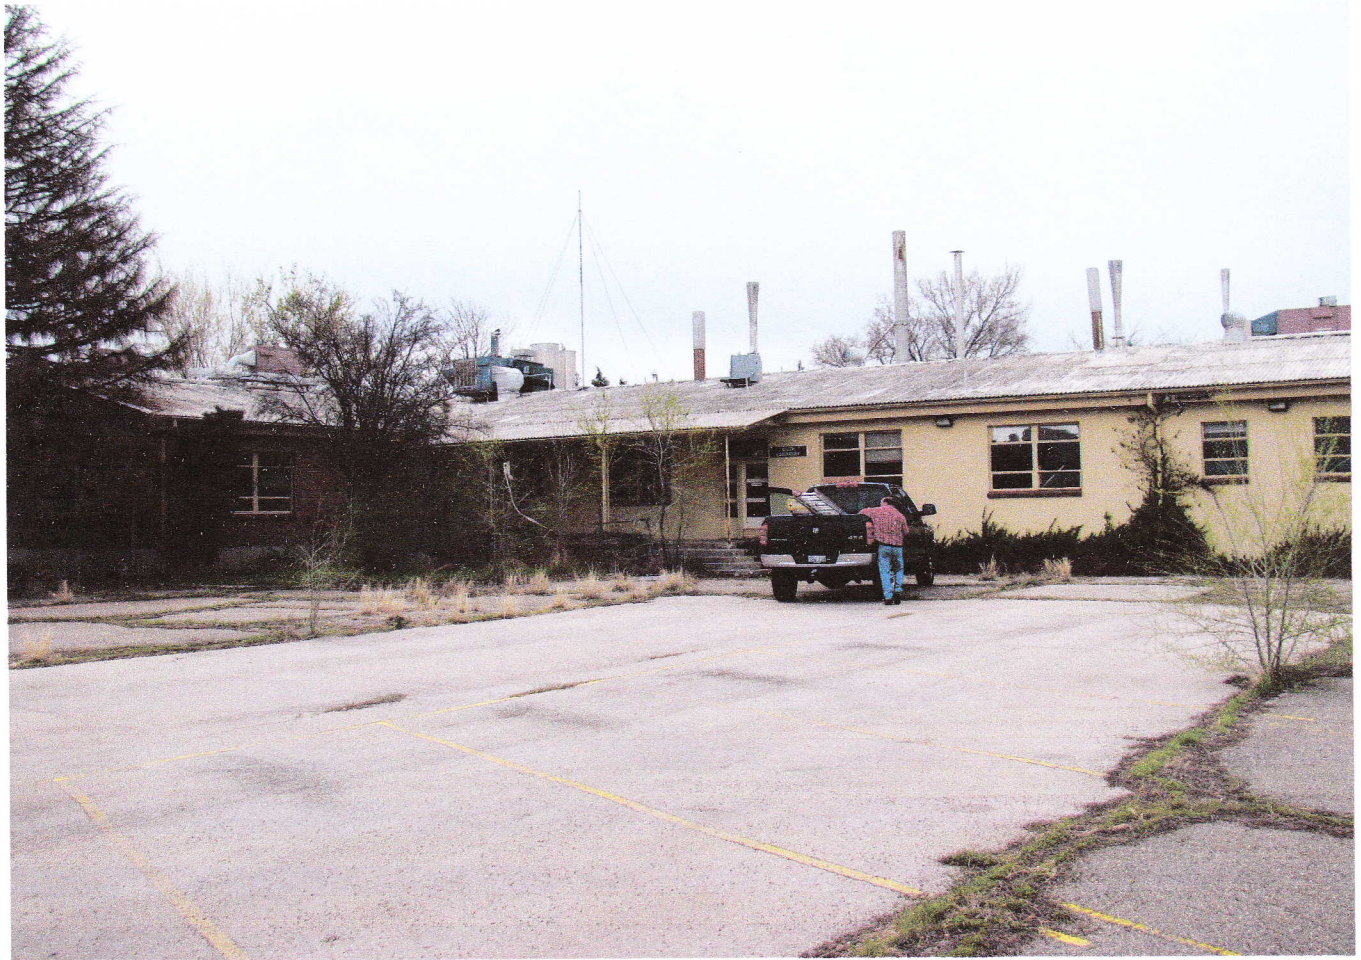
South Lab

This building has red bricking in front and plaster finish in back. It is T shaped. There is a basement on the west part. ( see photo ) There are 26 asbestos suspect materials. 11 samples were sent to the lab and 15 were assumed to contain asbestos. The list below is the material, the location of the material and estimated quantities. The table below is the material, estimated quantities, location of the sample taken and the % of asbestos.

The assumed flooring, gaskets, glue pucks, window putty and cove moldings can be left in during demolition. **The pipe insulation, mud elbows, furnace tape, asbestos blankets and cloth dampers Must be removed before demolition as friable class 1 material. The transite roof, fascia, black table tops and transite exhaust hoods must be removed before demolition. This is a class 2 material but still must be removed before demolition. All work must be done by a certified asbestos company.**

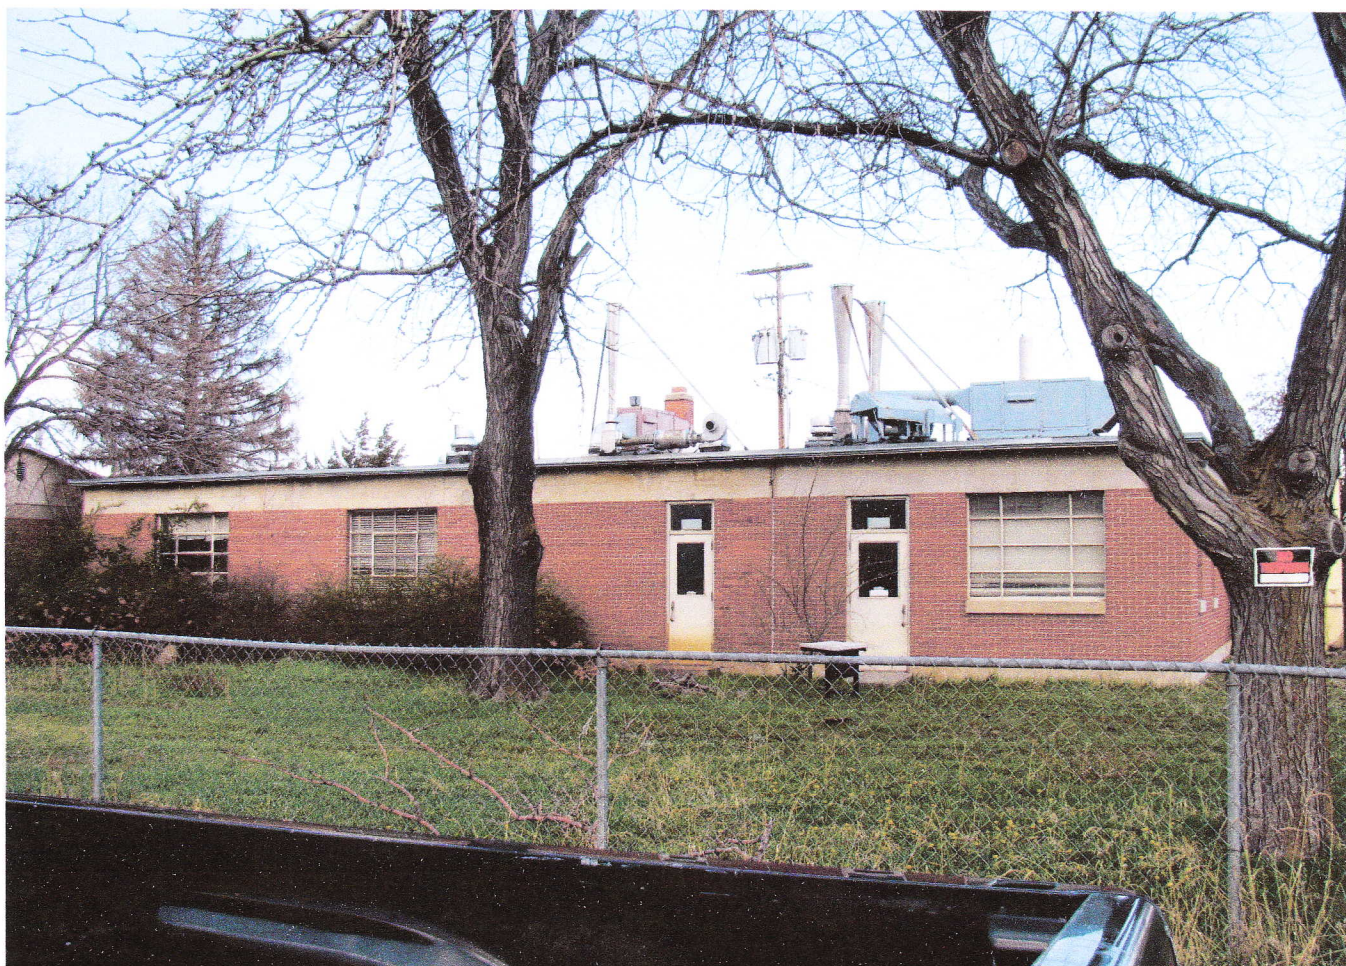
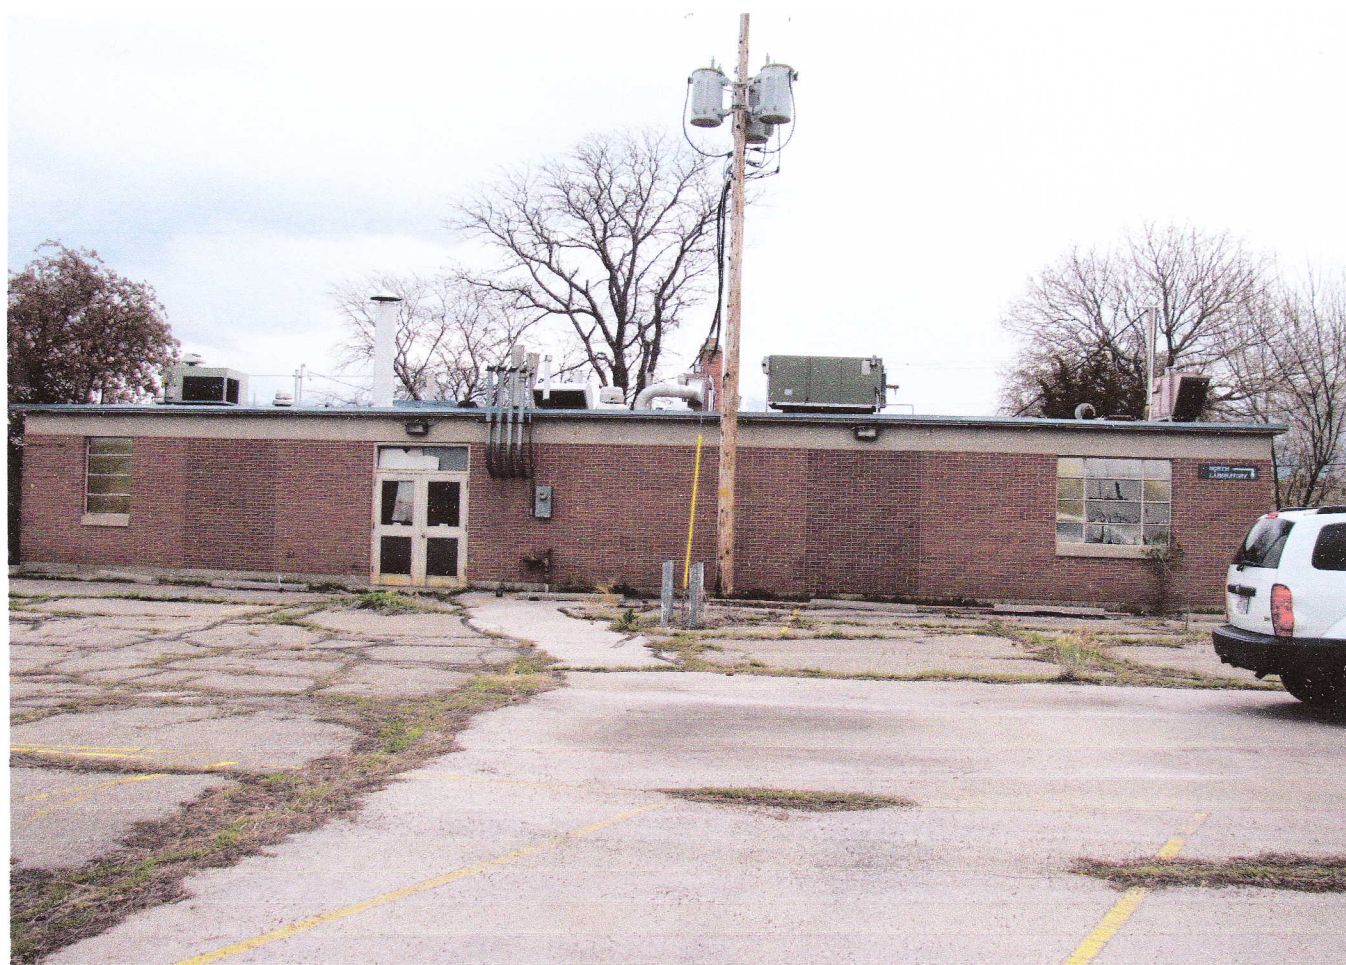
North Lab

The north building is a red rectangular building that set on a slab. It has a asphalt roof and cement trusses. ( see photo ) There are 13 asbestos suspect material. 6 were sent to the lab for analysis and 7 were assumed to contain asbestos. The list below is all the suspect materials, location of material and estimated quantities. The table below is all materials, estimated quantities, sample location and % of asbestos.

ND = Non Detected The size of the building is 5600 sq ft. The elbows and the white pipe insulation contain amosite asbestos . The reason for this inspection is to demolish the building. The Cove molding, all floorings Glue pucks, window putty and roofing can be left in during demolition.

**The Elbows and hard pack pipe insulation is the same Class 1 friable material. It contains amosite asbestos and must be removed by a certified asbestos company**  
**The cloth dampers are also friable class 1 material and must be removed by a certified asbestos company before demolition**

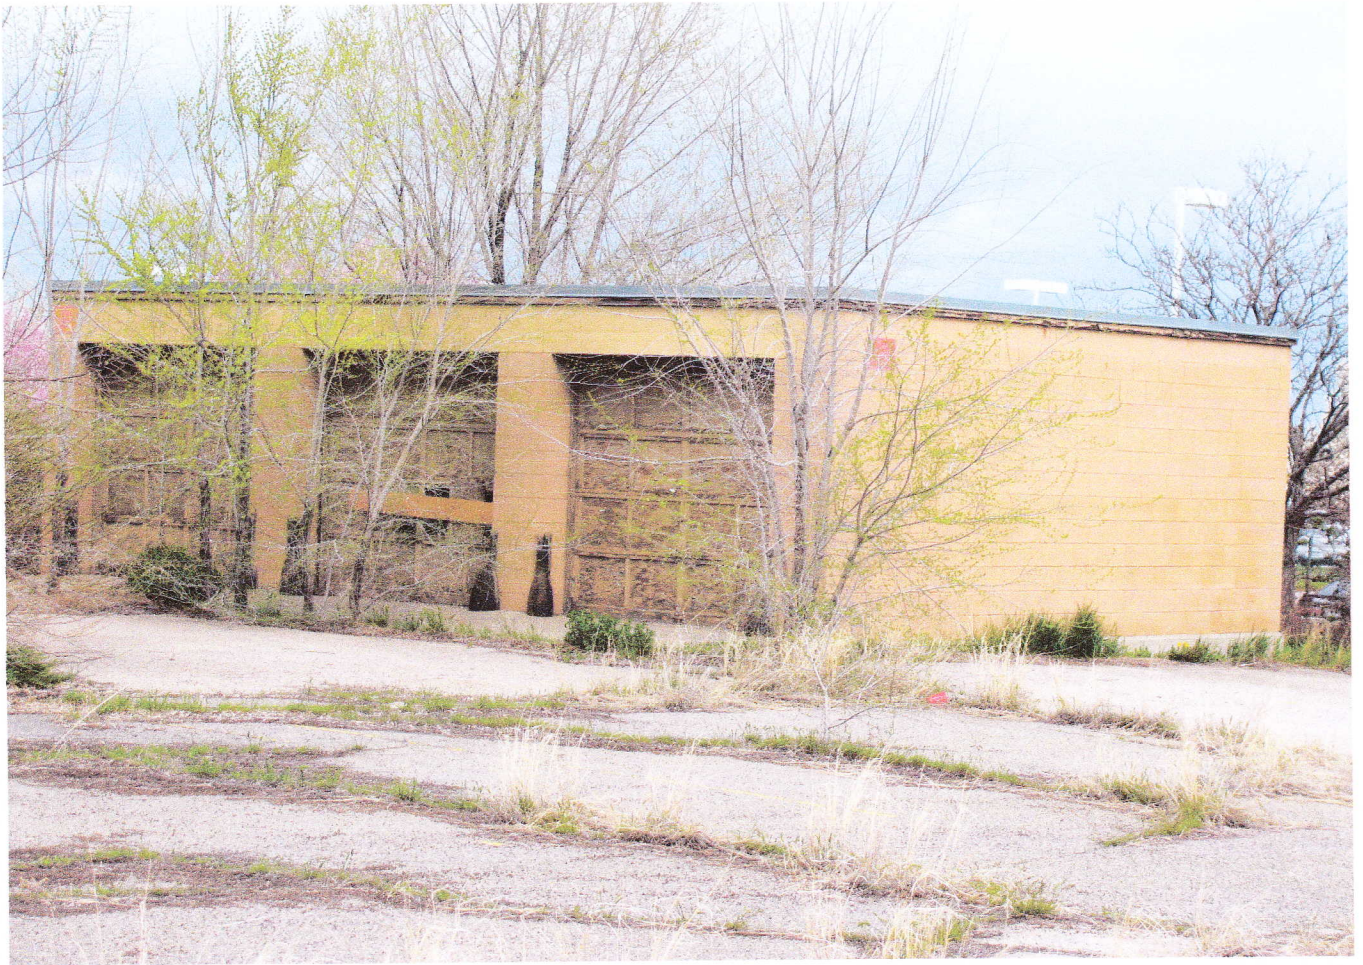
Garage

The building is a yellow block garage. ( see photo ) There is only 1 asbestos suspect material and it is assumed to contain asbestos. This is the roofing material. There is 800 sq ft of roofing and it is located on the roof. The size of the garage is 800 sq ft. The assumed roofing can be left in during demolition. **No asbestos abatement needed before demolition.**
